# Harmony

## LATILLA

Back to Wall Toilet Suite

PRODUCT CODE: **HARMONY10160**

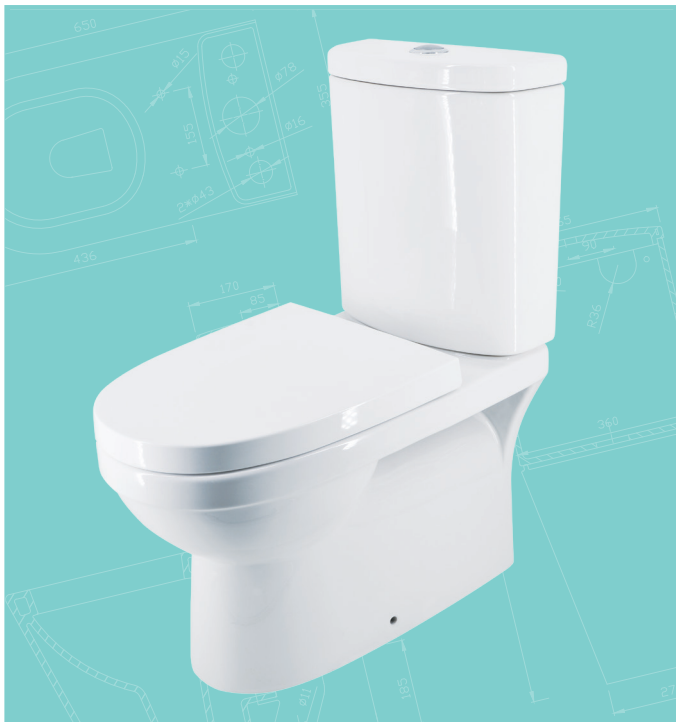
<b>RIM CONFIGURATION</b>	Box Rim
<b>WASTE OUTLET</b>	S or P Trap using Universal Connector
<b>INLET</b>	Back (Top) Inlet on left of cistern
<b>SEAT</b>	Soft-Close
<b>COLOUR</b>	White
<b>MATERIAL</b>	Vitreous China
<b>PAN SET-OUT</b>	90-200mm
<b>WEIGHT</b>	27kg Pan, 14kg Cistern
<b>FLUSHING (Ltr)</b>	4.5 Litres Full Flush, 3.0 Litres Half Flush, 3.5 Litres Average Flush
<b>WELS RATING</b>	4 Star
<b>AUSTRALIAN STANDARDS</b>	AS1172.1-2014 AS1172.2-2014
<b>WARRANTY</b>	10 Years Pan & Cistern, 2 Years Seat, 5 Years Valves, 1 Year Push Buttons
